# INNOVATIONS IN THE DESIGN OF EMERGENCY SHUT-DOWN ACID INJECTION VALVES FOR HIGH PRESSURE ACID LEACHING OF NICKEL LATERITE ORE

Malcolm J Harrison

Valvtechnologies, Inc., 5904 Bingle Road, Houston, Texas 77092, USA

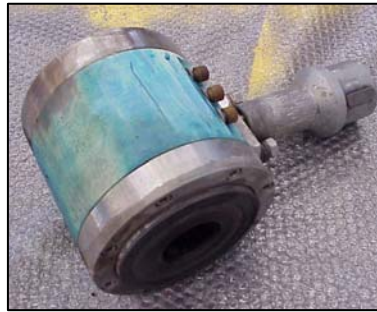
**Figure 6. Valve after removal.**

A series of pictures taken after removal of a primary isolation valve, in tantalum material, illustrated these results.

- Figure 6 shows the valve after removal.
- Figure 7 shows the autoclave side of the ball where the chrome oxide coating had failed, but still had maintained an acceptable seal.
- Figure 8 shows the opposite side of the ball and indicates the process fluid had not leaked across the valve.
- Figure 9 shows the ceramic seat on the autoclave side of the valve and indicates the slight leak path.
- Figure 10 shows the ceramic seat on the opposite side of the valve and appears undamaged.

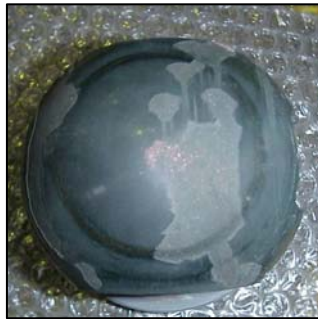
**Figure 7. Autoclave side of ball.**

Corrective action was taken to upgrade the coating to titanium dioxide ( $Ti_2O_3$ ) as this coating had been seen to perform well on other equipment at the plant with a higher bond strength and better corrosion resistance.

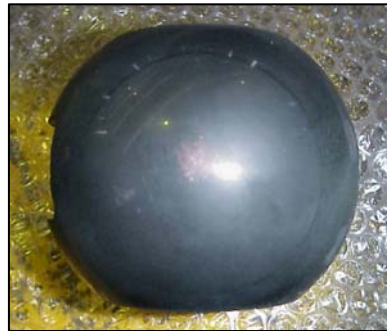
**Figure 8. Opposite side of ball.**

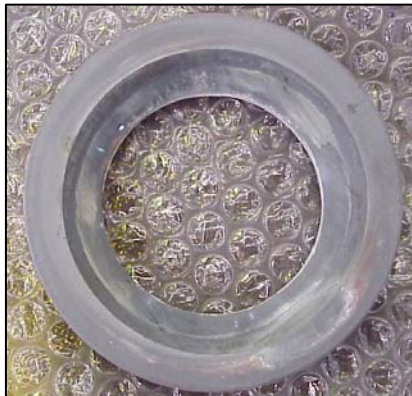
**Figure 9. Seat on autoclave side.**

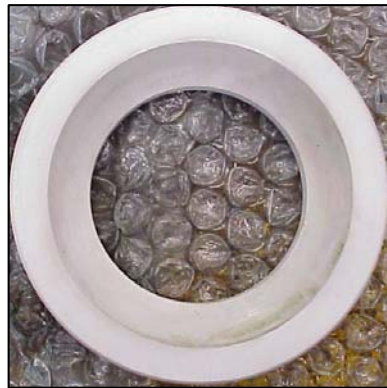
**Figure 10. Seat on opposite side**

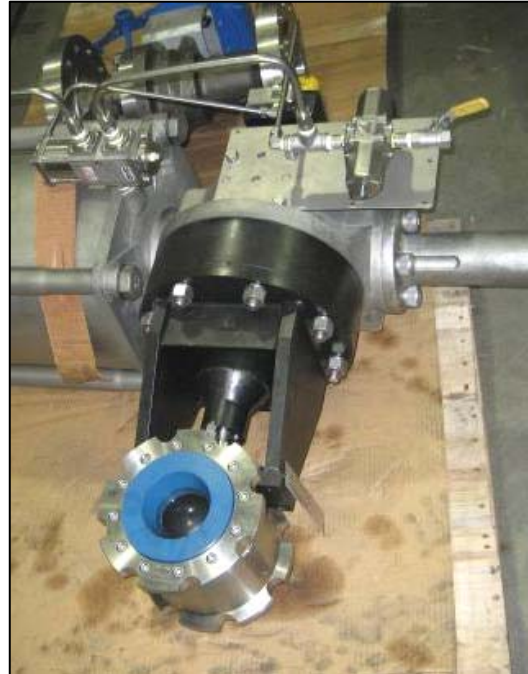
**Figure 13. Goro valve**

The valve maintenance work at Murrin Murrin had been executed by a company (Score-Pacific) in Western Australia that specialized in the on-site plant maintenance of all types of valves. This company had worked closely with Valvtechnologies in upgrading the acid injection system valves and was certified as the Valvtechnologies service agency. Goro engaged this company as consultants for their valve selection process and as a result many upgrades were incorporated into the design specifications and valves manufactured (see Figures 11, 12 & 13)

- Body designed to have external alignment guides for easier installation between flanges.
- Stem increased in diameter by 10% and material changed to tantalum with 10% W (UNS R205256).
- Ball coating changed to titanium dioxide ( $Ti_2O_3$ ).
- Body material and flange retainers changed to Alloy 20.
- Actuator mounting changed from carbon steel to stainless steel.
- Actuator and all accessories changed to stainless steel.
- Top-works of the valve equipped with a bearing to better support the actuator (see figure 13).

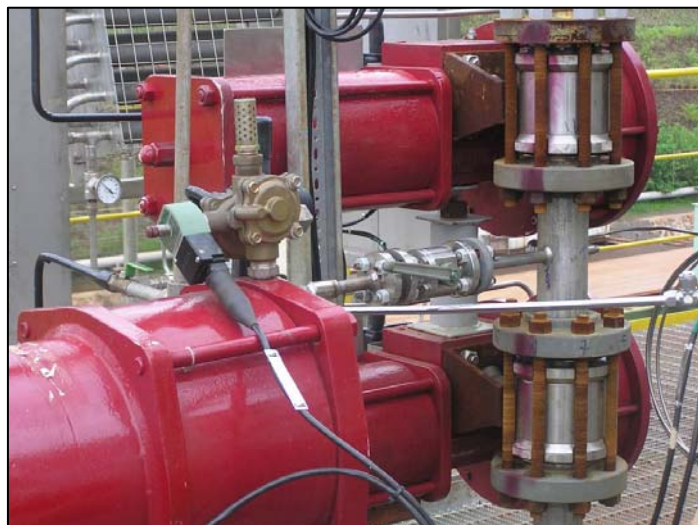
### **Figure 14. Rio Tuba acid isolation valves**

During the Goro work valves were supplied to the Coral Bay HPAL Nickel Plant (Rio Tuba) in the Philippines. The design used tantalum valves in a double valve arrangement with a nitrogen purge connected to a center spool (see Figure 14). These valves did not have the benefit of all the upgrades applied for Goro but have still functioned well and have operated in shut-down mode with reliable results. For the current upgrade at Rio Tuba, latest generation valves are now being provided. In late 2007, Valvtechnologies was awarded the supply of all acid injection system valves for the Ambatovy HPAL Nickel Plant in Madagascar and have recently provided a proposal to the Ramu HPAL Nickel Project in Papua New Guinea.
