# High-Temperature Boiler Steam Stop Valves — Beware of a Hidden Problem

Be forewarned, hardface disbonding is something frightening to behold.

By Joseph Miller

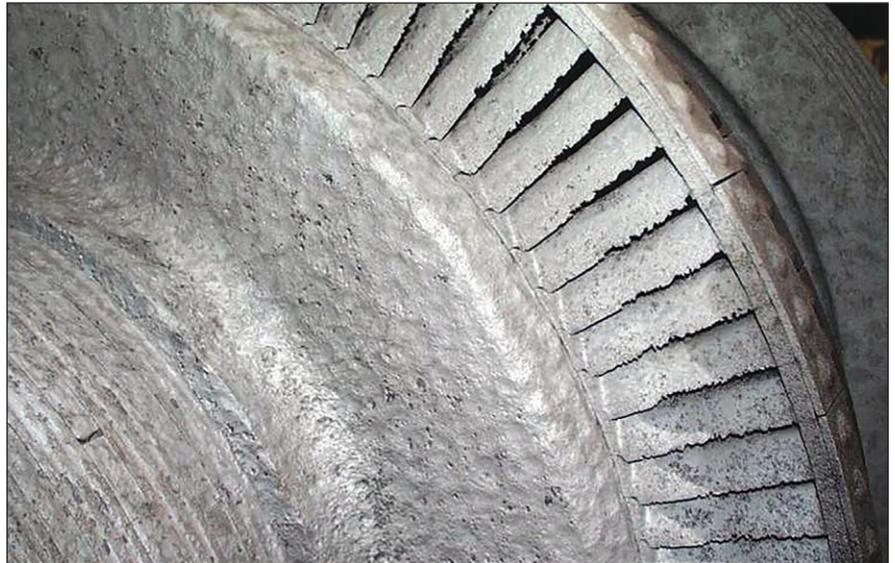
Figure 2. HP turbine first-stage damage due to liberated pieces of hardfacing.

Disbonding of steam stop valve hardfacing has predominately been a power industry issue affecting mainly combined cycle power plants and, to a lesser degree, coal-fired power stations. Besides the loss of isolation integrity from disbonding, entrained pieces of hardfacing material can breach the steam turbine screens and cause blade path damage as evidenced in Figure 2. If a section of hardfacing is not visibly missing, the only means to determine if hardface disbonding is occurring is to perform UT inspection.

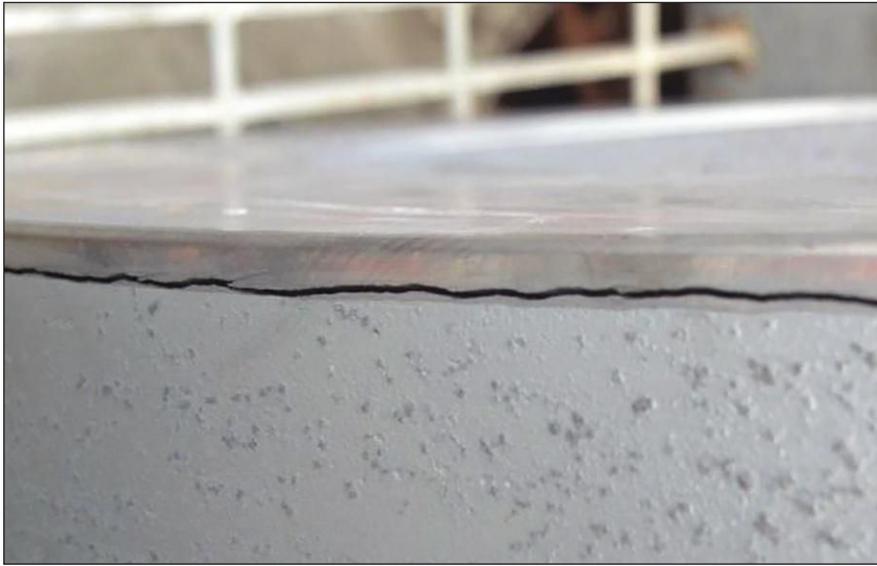
**Figure 3. Interfacial crack at base metal substrate and hardface boundary.**

EPRI's investigations focused on the metallurgical structure of the base metal substrate/cobalt alloy interface boundary layers. These boundary layers were found to contain a brittle intermetallic Sigma phase that formed from the base metal and cobalt alloy weld pool. Circumferential, subsurface cracking propagates in the interface boundary possibly due to this brittle Sigma phase. Operating time at elevated temperature appears to be a factor,
