Case Study

The Costly Impact of Improper Valve Installation

Location: Italy Plant type: Combined Cycle Power Plant Industry: Power Application: Non-modulating control Product: Xactrol® Mark I Valve

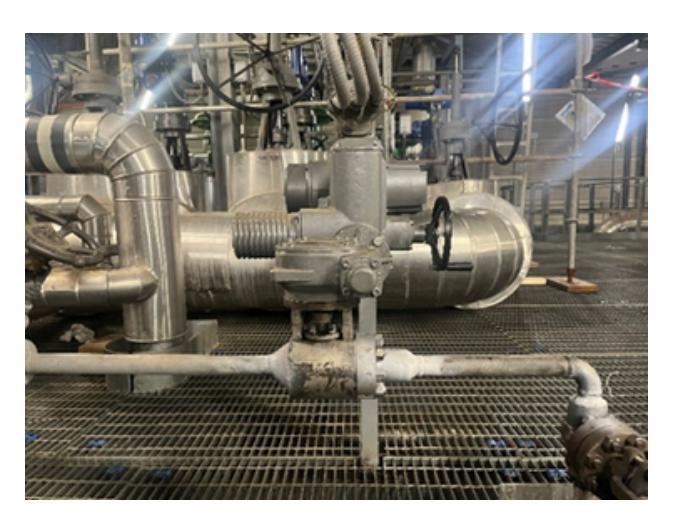
Testing on the valves results:

- Economizer that is not getting pressurized.
- Parts had been installed incorrectly and were not the correct orientation, critical components of the valve caused severe damage to the internal components.

The strip-down of the valve revealed that parts had been installed incorrectly and out of orientation. Critical valve components, such as the seat and ball, were misaligned, causing extensive damage to the internal structure. The root cause was the lack of product training and excessive force applied during the actuator installation.

The decision was made to replace all internal spare parts in both valves, including the ball and end caps.

It is crucial only trained and approved personnel install actuators on ValvTechnologies valves to prevent voiding any warranties and ensure that critical components are properly aligned during installation.
