POWER

Vol. 151 • No. 8 • August 2007

PREVENTIVE MAINTENANCE

Stop valves from leaking money

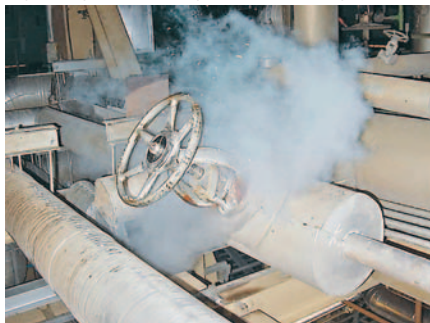
1. Look familiar? Over one year, the cost in wasted fuel of ignoring a leaking isolation valve is typically many times the cost of replacing it. *Courtesy: Valvtechnologies*

Testing valves for leakage costs little but can save a lot. Energy drops across many valves exceed 1,250 Btu/lb, and leakage rates can be higher than 1,000 lb/hr. In a plant burning fuel priced at \$5 to \$10 per million Btu, a single valve with a modest leak (Figure 1) can account for \$50,000 to \$100,000 in lost fuel costs annually. That's at least an order of magnitude greater than the \$3,000 to \$6,000 cost to replace it.

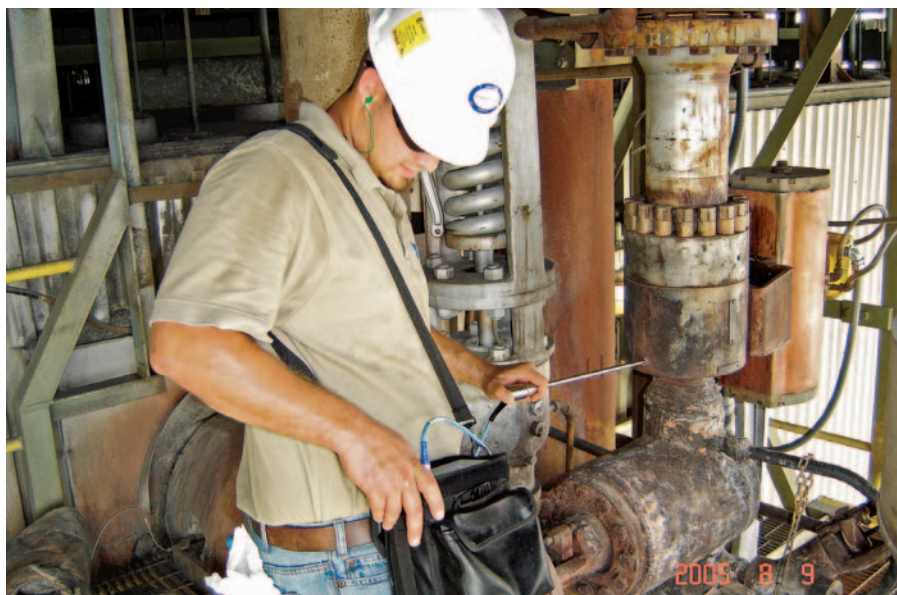
2. Probing the pipe. Ultrasonic emissions testing is nondestructive, intrinsically safe, and nonintrusive to normal plant operations. *Courtesy: Valvtechnologies*

- Thermographic testing may require removing large amounts of insulation from multiple locations along a pipe. UET only requires drilling a few, easily pluggable 1/2-inch holes in the pipe’s aluminum jacket to accommodate a 3/8-inch-diameter probe to make contact with the valve and the adjacent pipe (Figure 2).

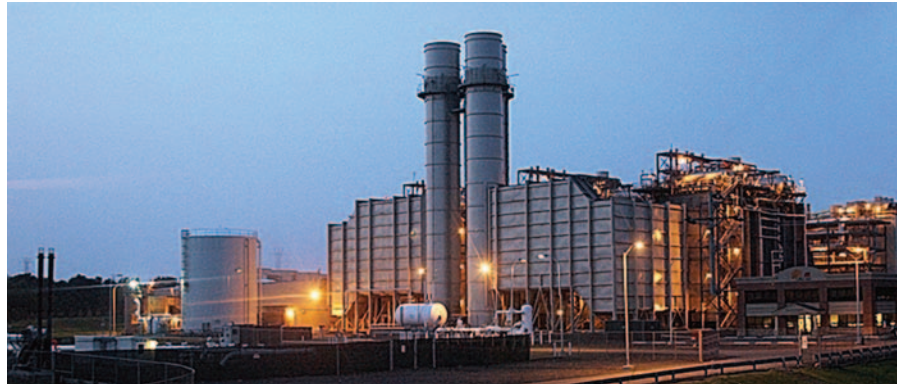
3. Do it yourself. The AES Red Oak plant in New Jersey found that top-quality shutoff valves often weren’t installed under its turnkey contract. An ultrasonic testing and valve replacement program paid immediate dividends in the form of lower unit heat rates. *Courtesy: AES*

AES Red Oak (Figure 3) is an 832-MW gas-fired 3 x 1 combined-cycle plant in Sayreville, N.J., that entered commercial service in September 2002. An energy trading

At the plant, which was built under a fixed-price contract, operators soon became painfully aware that many of its isolation valves were of low quality and prone to leaks. Among the concerns that the leaks raised were excessive plant heat rate and the possibility of water induction to the steam turbine.

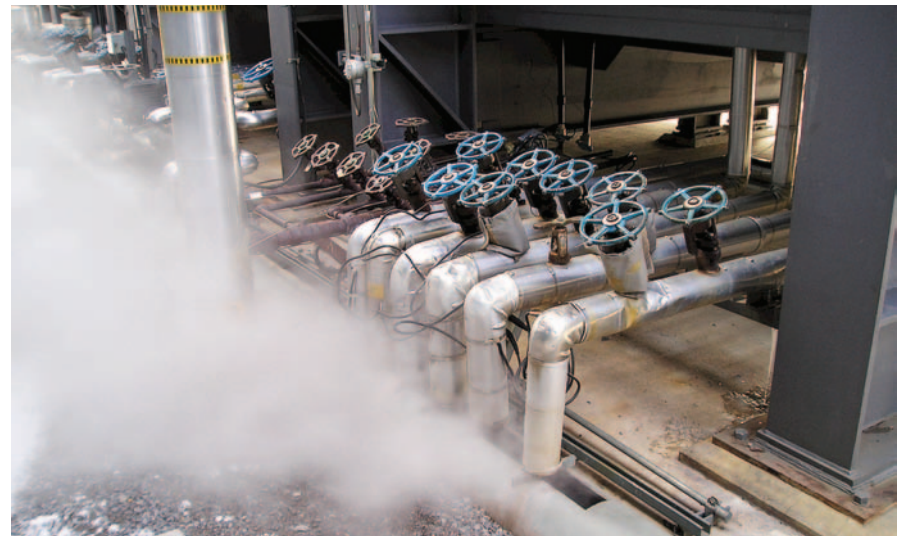
4. Time well spent. More than 50 valves were ultrasonically checked during a half-day of testing. *Courtesy: Valvtechnologies*

Marc Hain of AES Red Oak and Tony Glembocki of the valve designer and manufacturer Valvtechnologies (www.valv.com) teamed up to test those valves suspected of leaking. The two men targeted 50 valves for UET testing over the course of a half-day (Figure 4). “During the test, we opened and closed the targeted valves and adjacent block valves. When we com-

pared the sets of readings, it was clear that we were getting meaningful results,” recalls Hain.

Although the plant’s time and budget constraints didn’t allow for a complete valve replacement program, the testing did isolate the leakiest valves, which then were moved to the top of the O&M department’s list for repair or replacement. Testing also identified the “good” valves, which were sealing tightly.
